Aviation Investigation Preliminary Report

Location:	Portland, OR	Accident Number:	DCA24MA063
Date & Time:	January 5, 2024, 17:14 Local	Registration:	N704AL
Aircraft:	Boeing 737-9	Injuries:	177 None
Flight Conducted Under:	Part 121: Air carrier - Scheduled

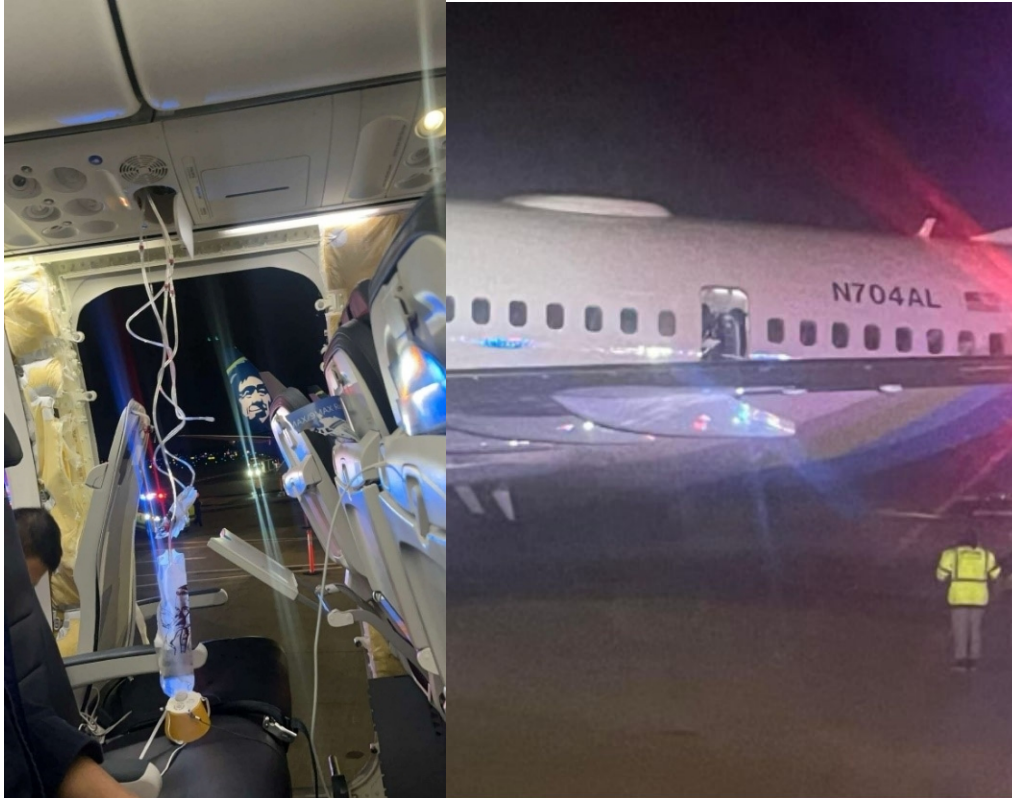
Figure 1 below shows the location of the missing MED plug from inside and outside the airplane. The separation of the MED plug from the airplane adversely affected the pressurization performance of the airplane and the damage to the MED plug adversely affected its structural strength, requiring replacement of the MED plug, resulting in a classification of substantial damage in accordance with Title 49 *CFR* Part 830.

Figure 1. Photos of the location of the missing MED plug. (Source: left photo provided by a passenger. Right photo provided by media.)

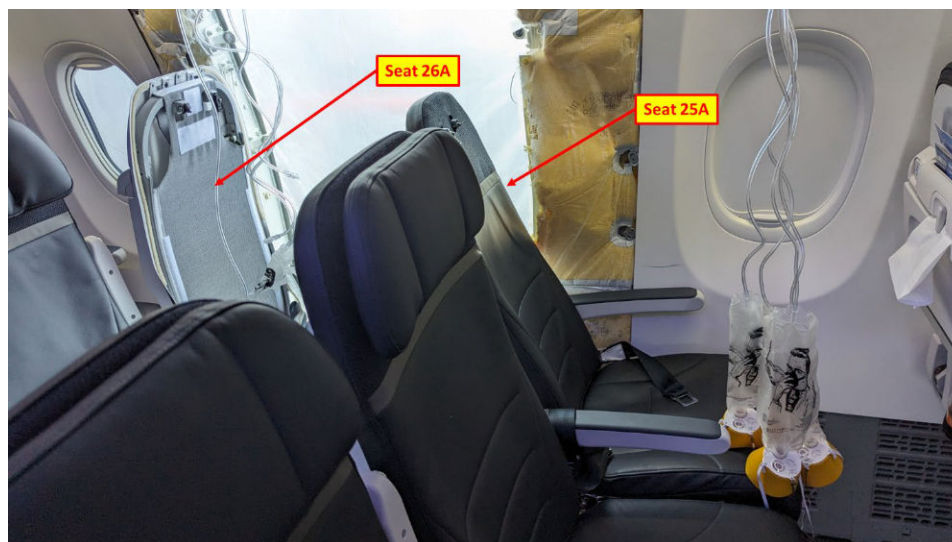
Damage to the passenger cabin included: damage in seat rows 25ABC and 26ABC as described below, deformation of the doorframe of the forward lavatory, and buckling and displacement of the sidewall panels and trim throughout the airplane. There were no indications of any other failures or malfunction of the airplane or any of its systems.

As seen in figure 7, Seat 25A was rotated out and aft approximately 10°–20° toward the opening. The seatback of Seat 26A was rotated forward and outboard.

Figure 7. Photo of seat rows 25ABC and 26ABC.

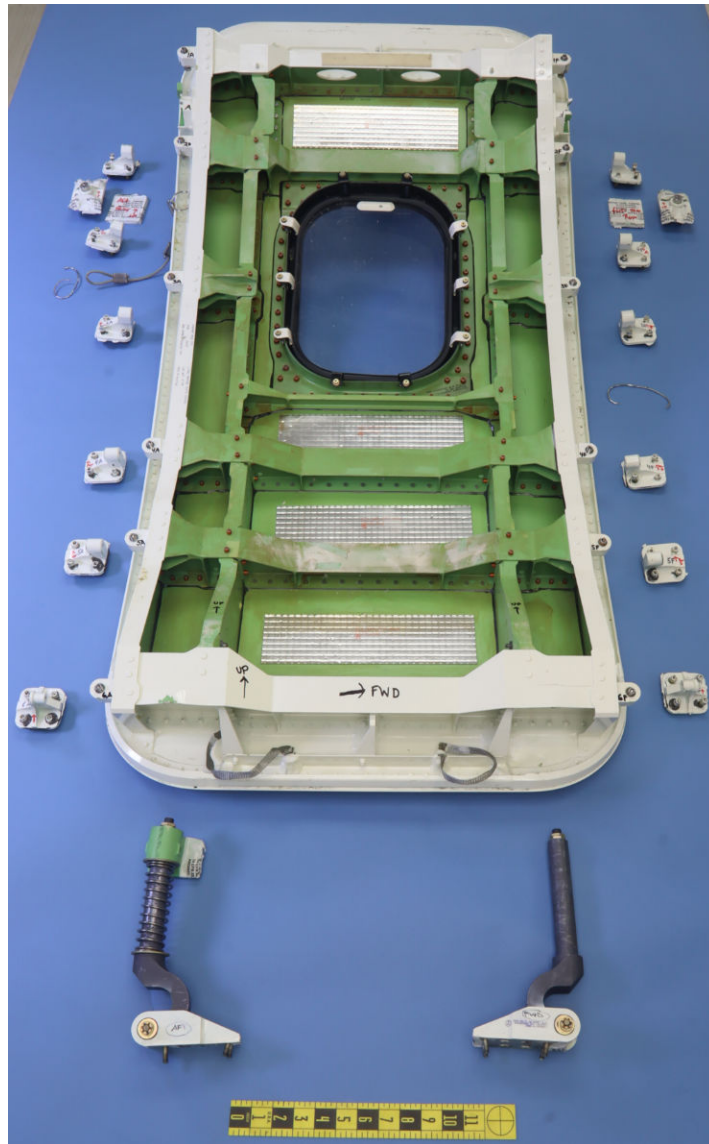
The NTSB Structures and Materials specialists, along with representatives from parties to the investigation, examined the MED plug and associated components removed from the accident airplane shown in figure 8 as received in the NTSB Materials Laboratory. The MED plug was mostly intact with some damage from the event and appeared to be manufactured in accordance with the engineering drawings.

Figure 8. Overall view of the MED plug and associated components removed from the accident airplane as received at the NTSB Materials Laboratory.

The two vertical movement arrestor bolts, two upper guide track bolts, forward lower hinge guide fitting, and forward lift assist spring were missing and have not been recovered. See figure 5 for example of installed locations.

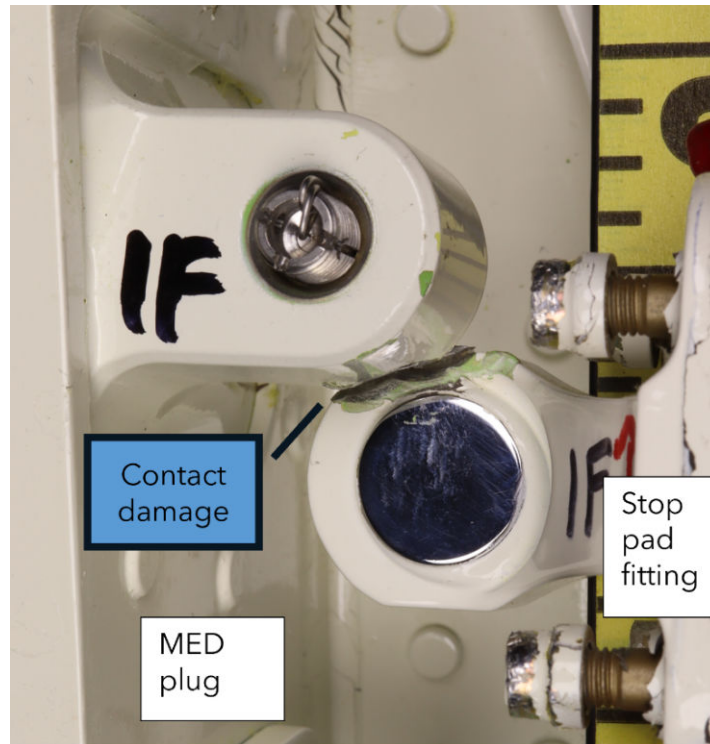
Contact damage was noted on the lower sides of the 12 stop pins and fittings on the MED plug. Corresponding contact damage was noted on the 12 stop pads and fittings attached to the fuselage. Overall, the damage was consistent with the MED plug translating upward, outboard, and aft during the separation. Figure 9 shows damage features at the upper forward stop location and is representative of the other stop locations.

Figure 9. Witness mark matching between upper forward MED plug stop pin fitting and stop pad fitting as received in the NTSB Materials Laboratory.

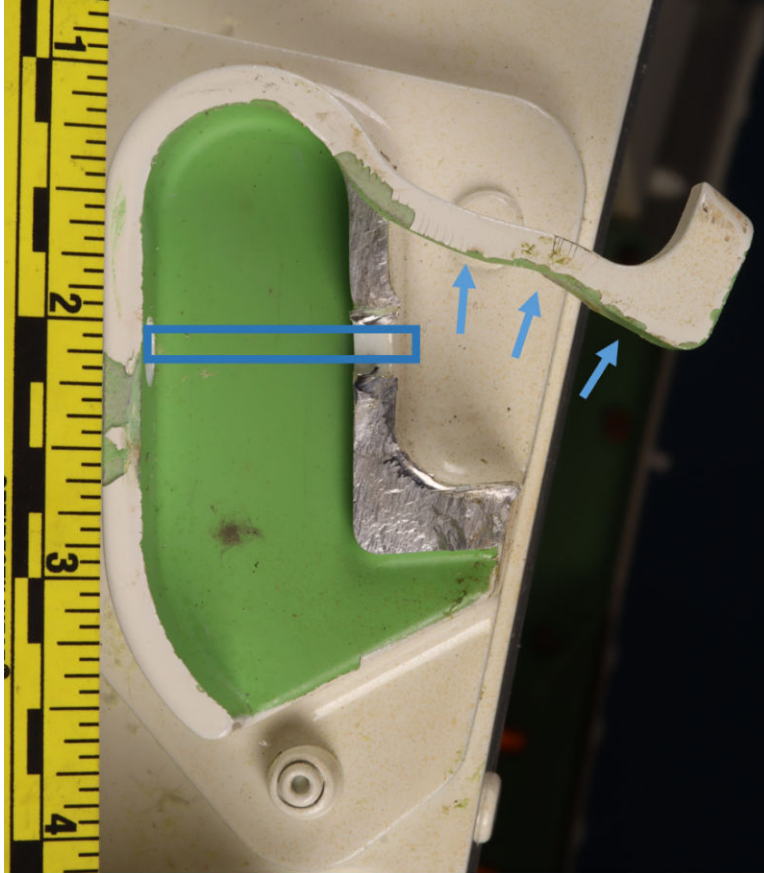
Both upper guide fittings installed on the forward and aft sides of the MED plug, respectively, were fractured vertically through the inboard wall of the track. Examination revealed features consistent with overstress fracture and no evidence of pre-existing cracks or damage. The outboard upper guide track bolt holes were intact and exhibited no deformation. Figure 10 shows the aft upper guide fitting; the forward upper guide fitting was similar.

Figure 10. Fractured aft upper guide fitting. Arrows point to the fractured and deformed piece of the guide fitting's inboard wall. The rectangle indicates where the upper guide track bolt would be installed.

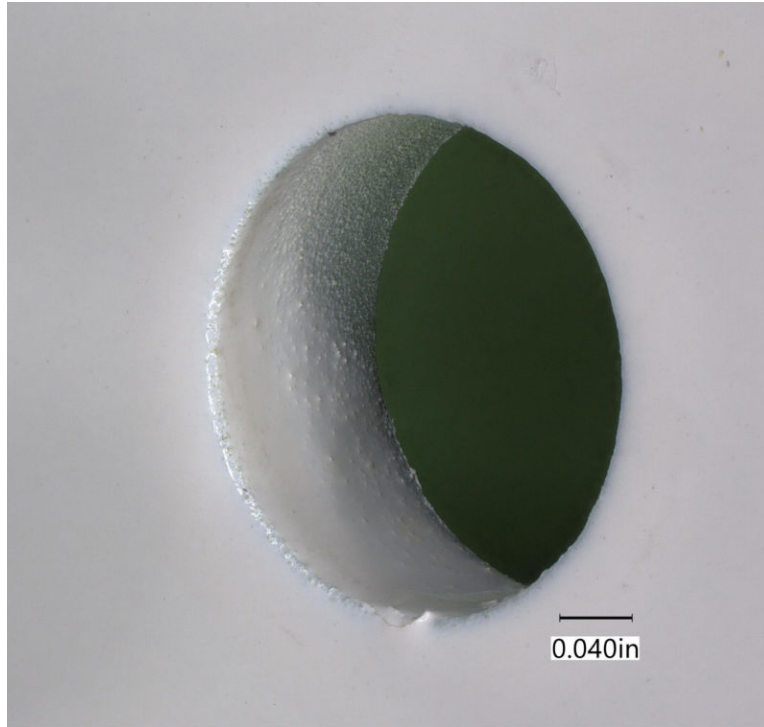
The paint in the upper guide track bolt hole bores was intact and showed no evidence of heavy contact damage. Figure 11 shows a representative hole bore. There were some light circular witness marks around the hole bores consistent with the presence of a washer at some time.

Figure 11. Aft upper guide track fitting showing the outboard track bolt hole bore.

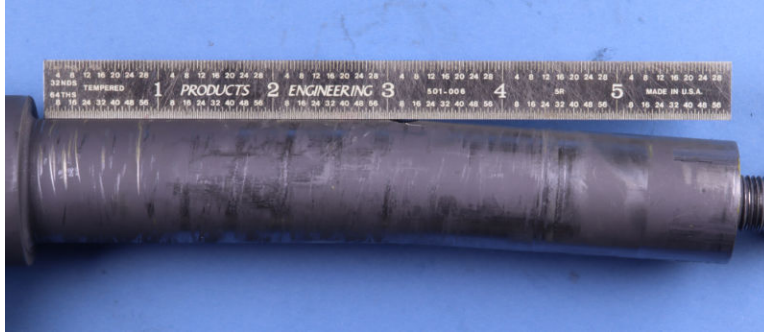
The aft hinge fitting was bent inboard about 3.7° with corresponding contact damage noted to the MED plug lower beam. Contact damage was noted on the inboard side of the hinge fitting shaft intersecting the vertical movement arrestor bolt hole consistent with contact with the MED plug, but the hole bore was otherwise undamaged. The outboard side of the vertical movement arrestor bolt hole was slightly elongated and exhibited small tensile cracks at the apex of the bend consistent with plastic deformation of the hinge fitting shaft (figure 12). The hole bore was otherwise undamaged.

Figure 12. Aft hinge fitting after disassembly showing the bent shaft.

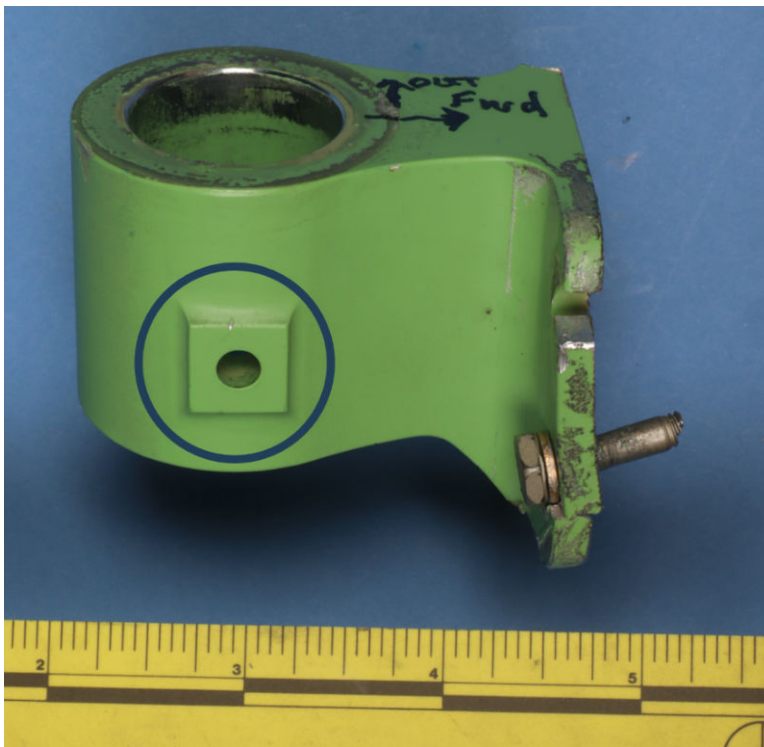
The attachment flange on the aft lower hinge guide fitting was fractured at the two upper attach hole locations, and the bolts remained installed in the MED plug. The two lower attach bolts were fractured. A similar damage pattern was noted on the MED plug at the forward lower hinge guide fitting attachment location. All features were consistent with ductile overstress fracture. The vertical movement arrestor bolt holes in the aft lower hinge guide fitting were intact and undamaged (figure 13).

Figure 13. Aft lower hinge guide fitting after disassembly. Circle shows the location of the vertical movement arrestor bolt hole.

Overall, the observed damage patterns and absence of contact damage or deformation around holes associated with the vertical movement arrestor bolts and upper guide track bolts in the upper guide fittings, hinge fittings, and recovered aft lower hinge guide fitting indicate that the

four bolts that prevent upward movement of the MED plug were missing before the MED plug moved upward off the stop pads.

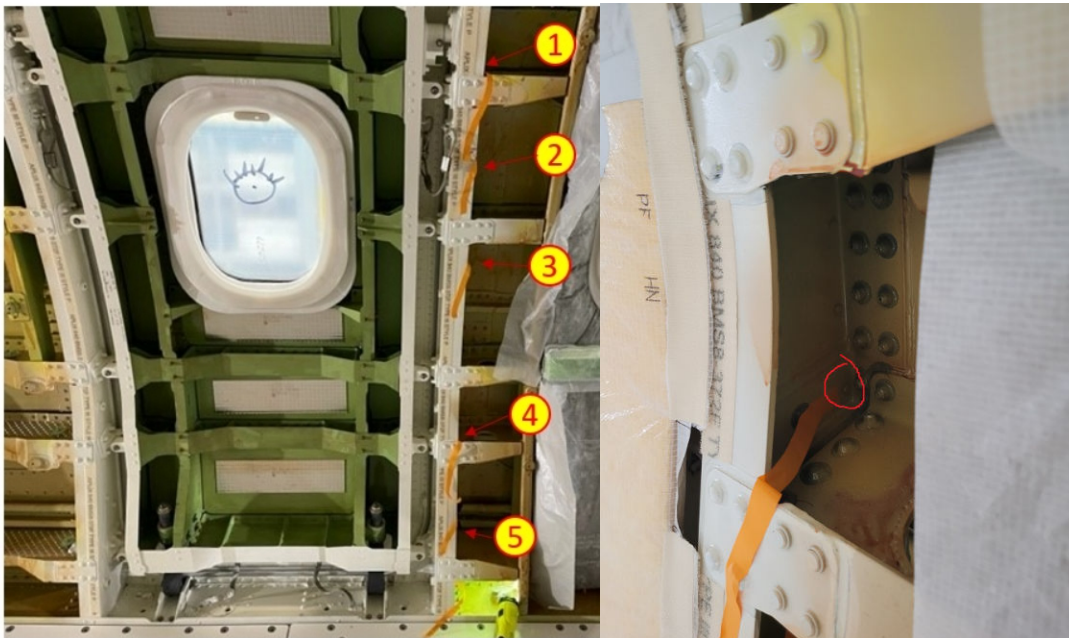
On September 1, 2023, records show that NCR 1450292531 was created noting five damaged rivets on the edge frame forward of the left MED plug. See figure 14 for rivet locations.

Figure 14. Photo on the left shows the five locations of the damaged rivets. Photo on the right is a close-up of a damaged rivet. (Source: Boeing. Image Copyright © Boeing. Reproduced with permission.)

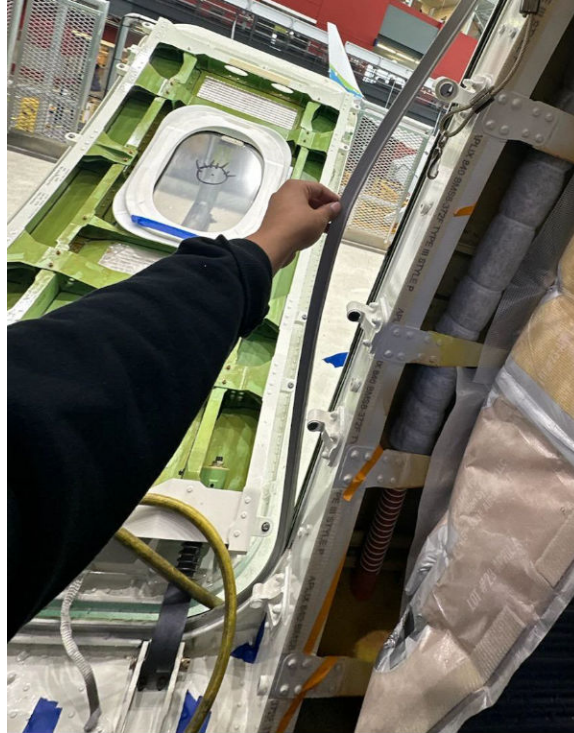
Documents and photos show that to perform the replacement of the damaged rivets, access to the rivets required opening the left MED plug (see figure 15). To open the MED plug, the two vertical movement arrestor bolts and two upper guide track bolts had to be removed.

Figure 15. Photo showing the MED plug opened to work on damaged rivets. (Source: Spirit AeroSystems.)

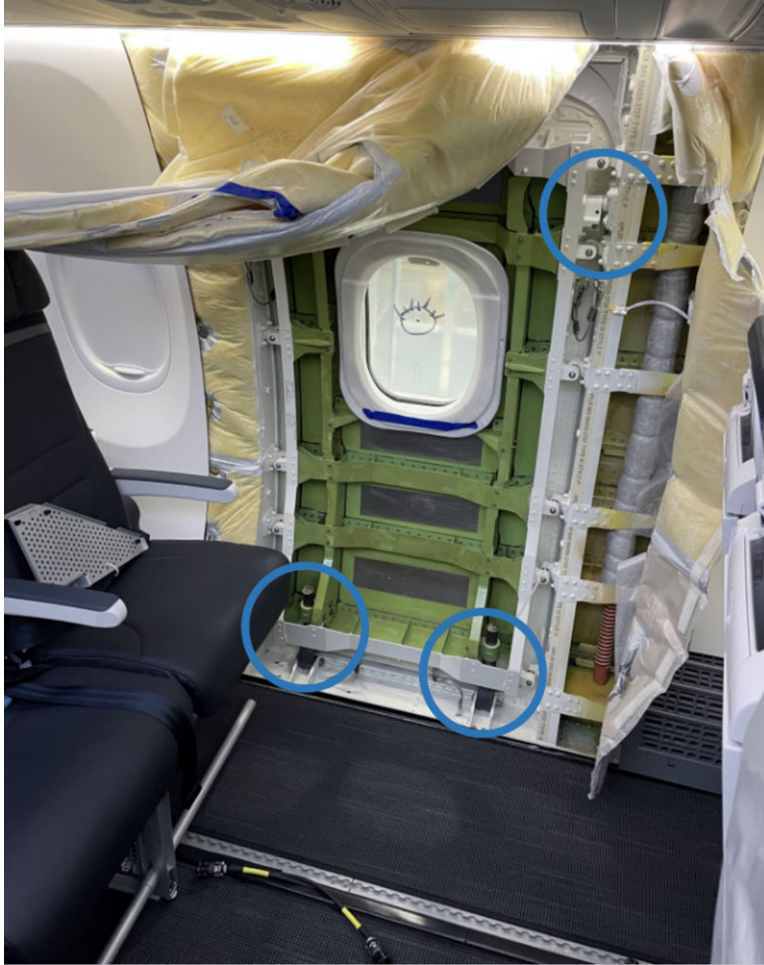
Records show the rivets were replaced per engineering requirements on Non-Conformance (NC) Order 145-8987-RSHK-1296-002NC completed on September 19, 2023, by Spirit AeroSystems personnel. Photo documentation obtained from Boeing shows evidence of the left-hand MED plug closed with no retention hardware (bolts) in the three visible locations (the aft upper guide track is covered with insulation and cannot be seen in the photo). See figure 16. This image was attached to a text message between Boeing team members on September 19, 2023, around 1839 local. These Boeing personnel were discussing interior restoration after the rivet rework was completed during second shift operations that day.

Figure 16. Photo showing the left MED plug immediately before interior restoration and the circles show the three locations without the retaining bolts, two vertical movement arrestor bolts and the forward upper guide track bolt. The aft upper guide track is covered with insulation and cannot be seen in the photo. (Source: Boeing. Image Copyright © Boeing. Reproduced with permission.)
