Aviation Investigation Preliminary Report

Location:	Portland, OR	Accident Number:	DCA24MA063
Date & Time:	January 5, 2024, 17:14 Local	Registration:	N704AL
Aircraft:	Boeing 737-9	Injuries:	177 None
Flight Conducted Under:	Part 121: Air carrier - Scheduled

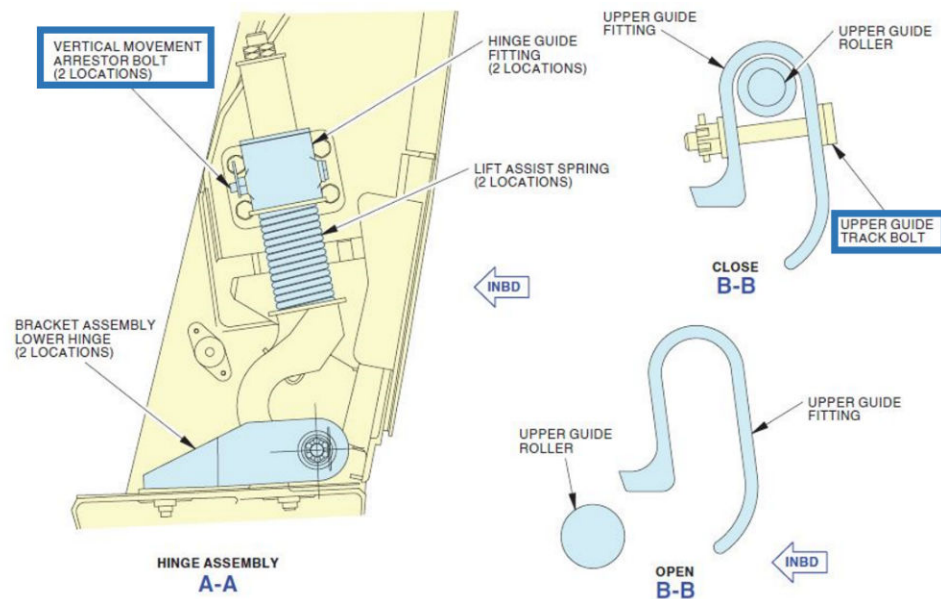
Once the plug is in place, it is secured from moving vertically by a total of four bolts. There is a bolt installed through each upper guide fitting and each lower hinge guide fitting. Once these bolts are installed, they are secured using castle nuts and cotter pins. Outboard motion of the plug is prevented by 12 stop fittings (6 along each forward and aft edge) installed on the fuselage door frame structure.

Figure 5. 737-9 Mid Exit Door Plug – Arrestor and Track Bolts. Boxes added for emphasis. (Source: Boeing. Image Copyright © Boeing. Reproduced with permission.)

The two vertical movement arrestor bolts, two upper guide track bolts, forward lower hinge guide fitting, and forward lift assist spring were missing and have not been recovered. See figure 5 for example of installed locations.
